**Central Modoc Resource**

# *Restoration in the Pit River Watershed : Landowner-Led Cooperative Conservation*

presented by Cliff Harvey  
CMRCD Watershed Coordinator

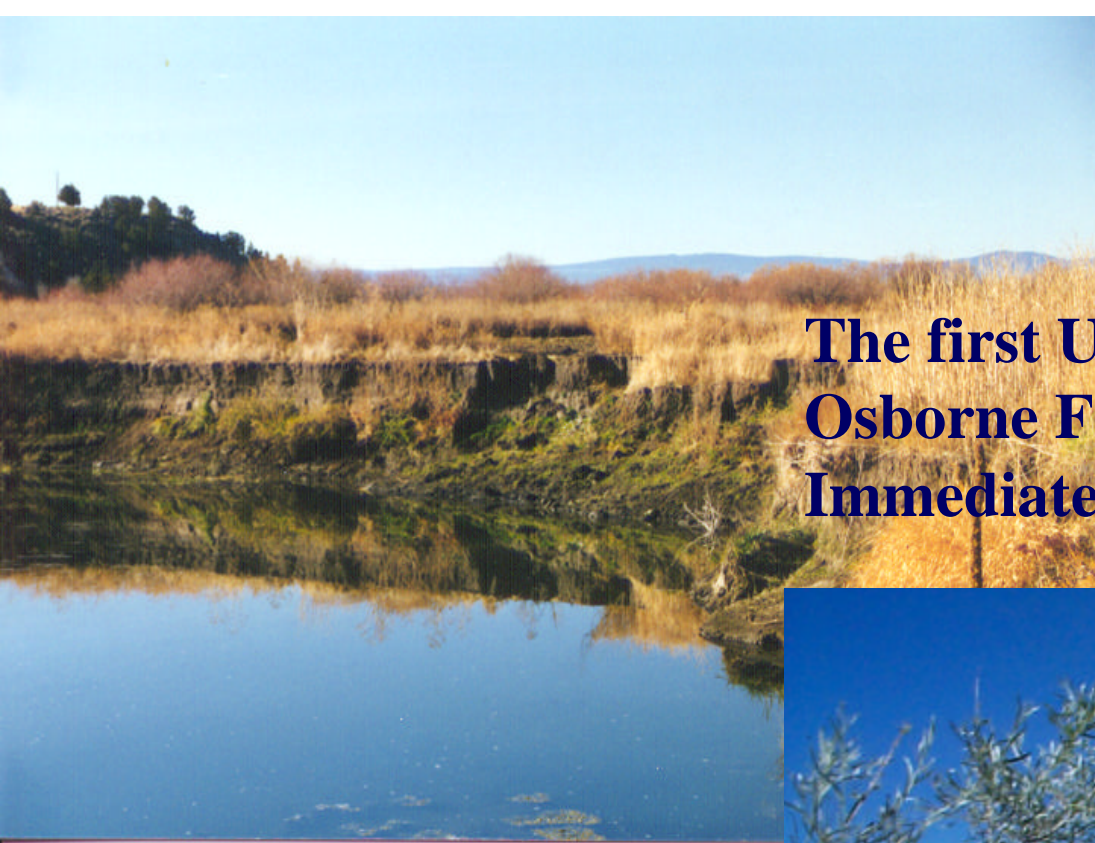
**The first UPRWEPP project site,  
Osborne Farms, North Fork Pit River  
Immediately before treatment, 1996**

**Osborne Farms site,  
summer 2001  
Vegetated riprap  
now features  
well-established  
native willow growth**

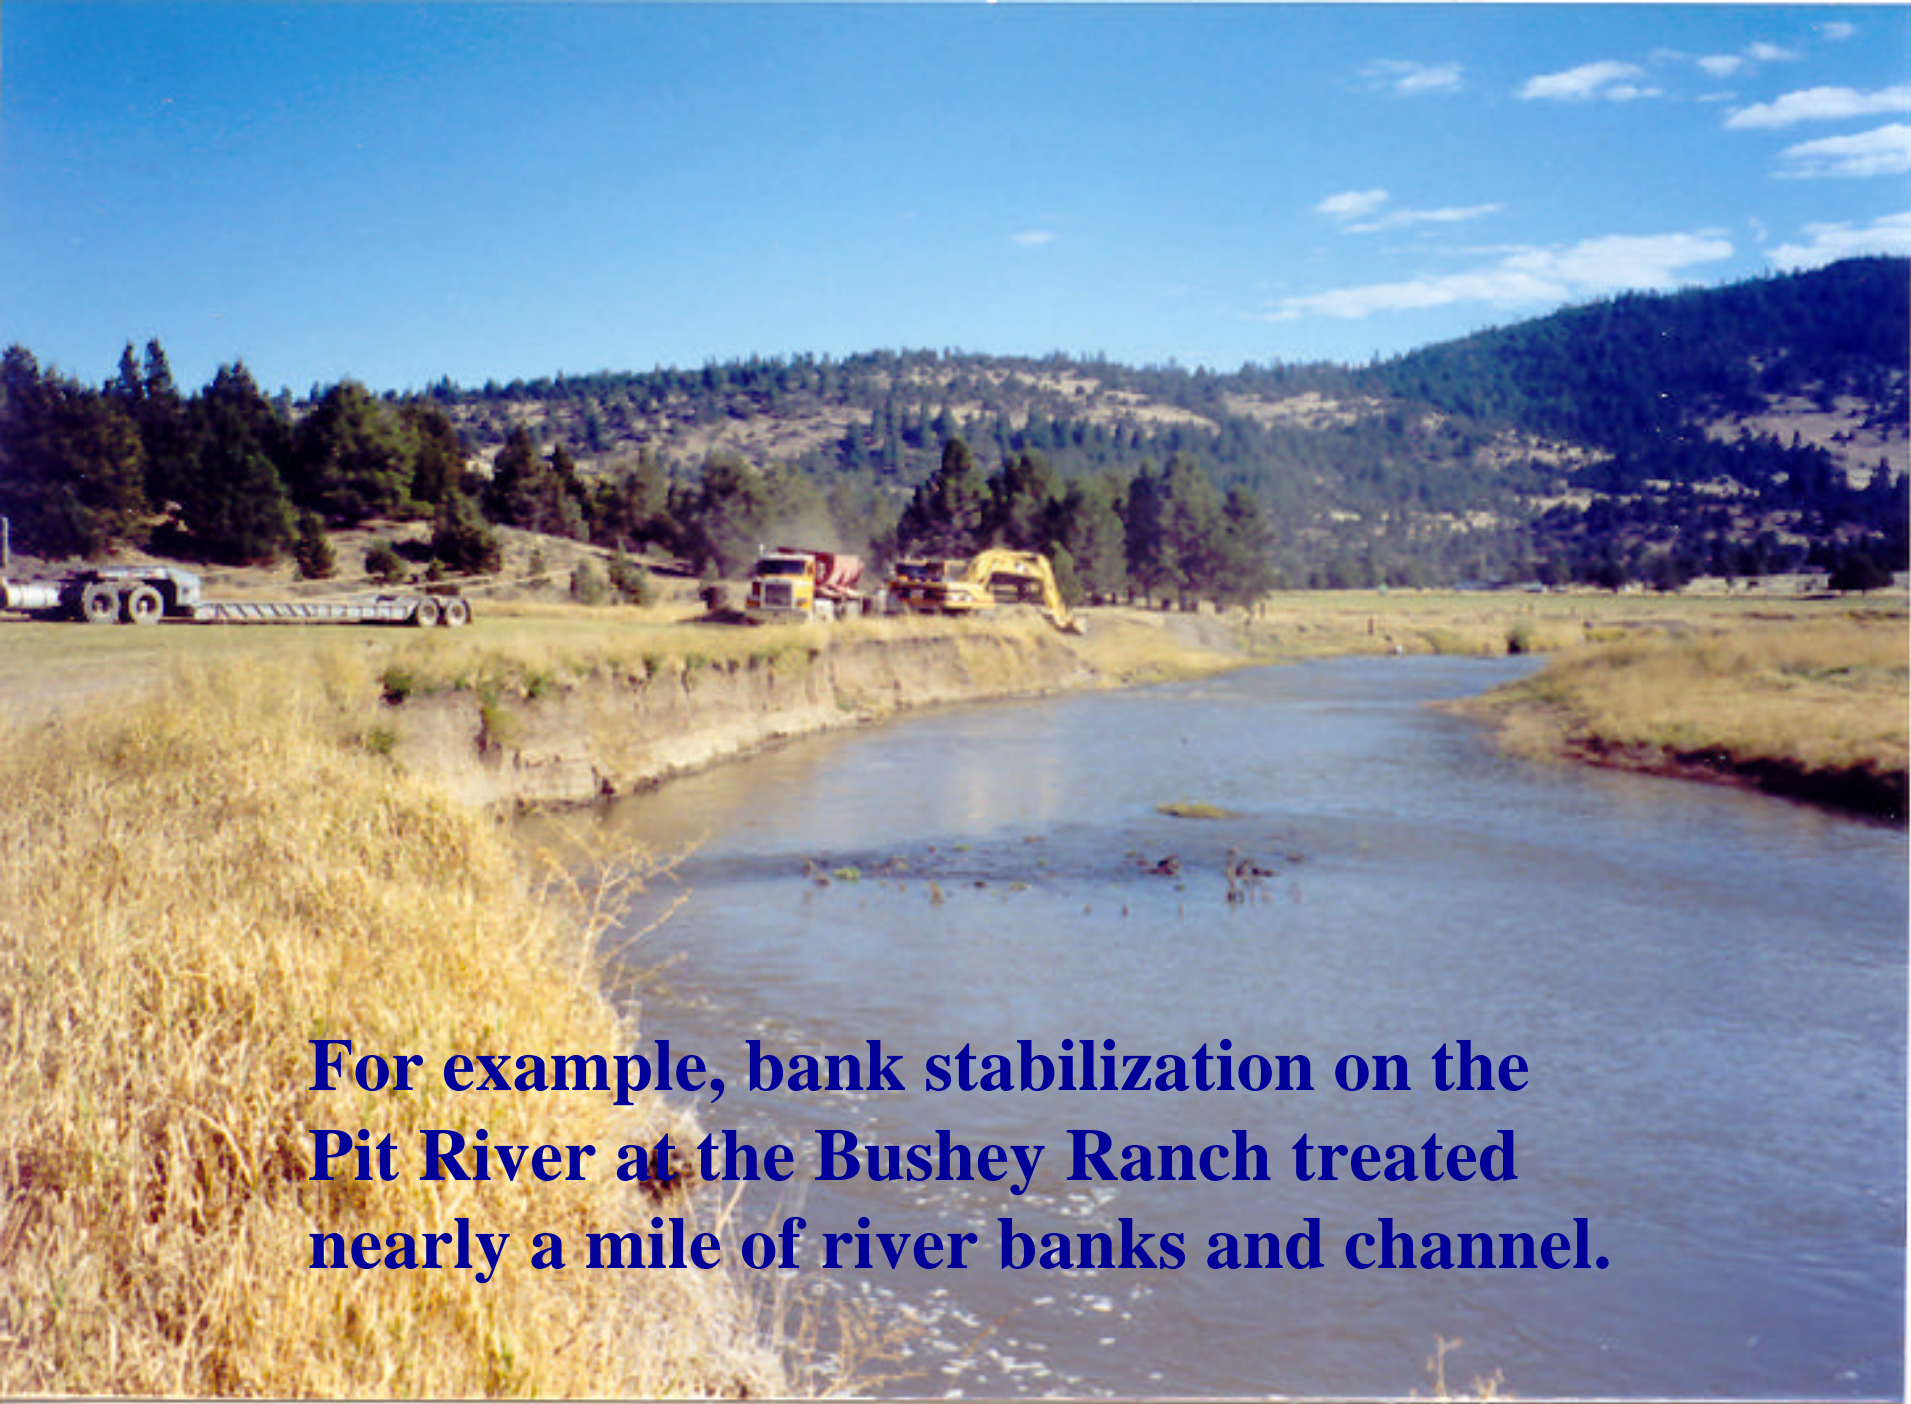
**For example, bank stabilization on the Pit River at the Bushey Ranch treated nearly a mile of river banks and channel.**

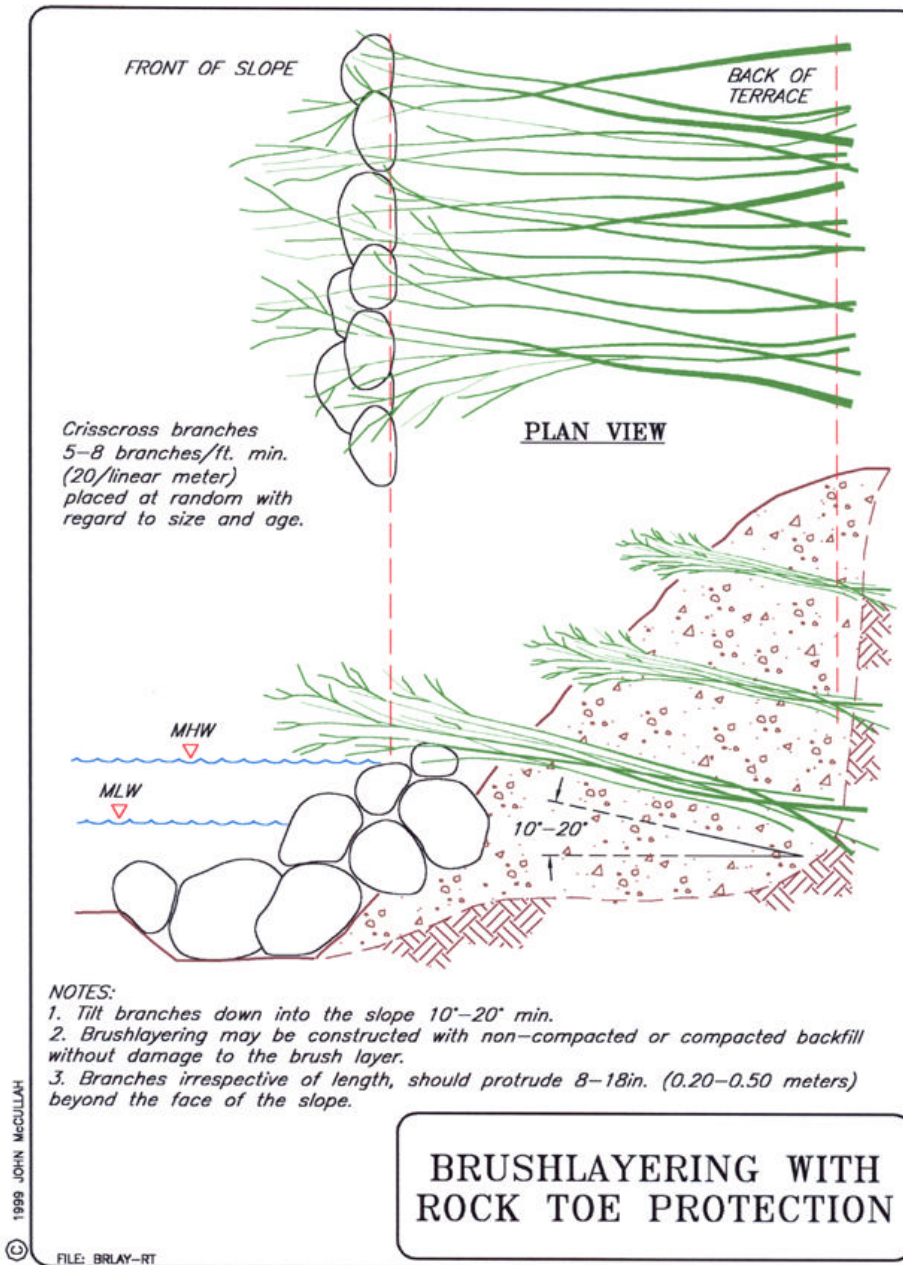
**Biotechnical  
treatments were  
prescribed for  
all sites,**

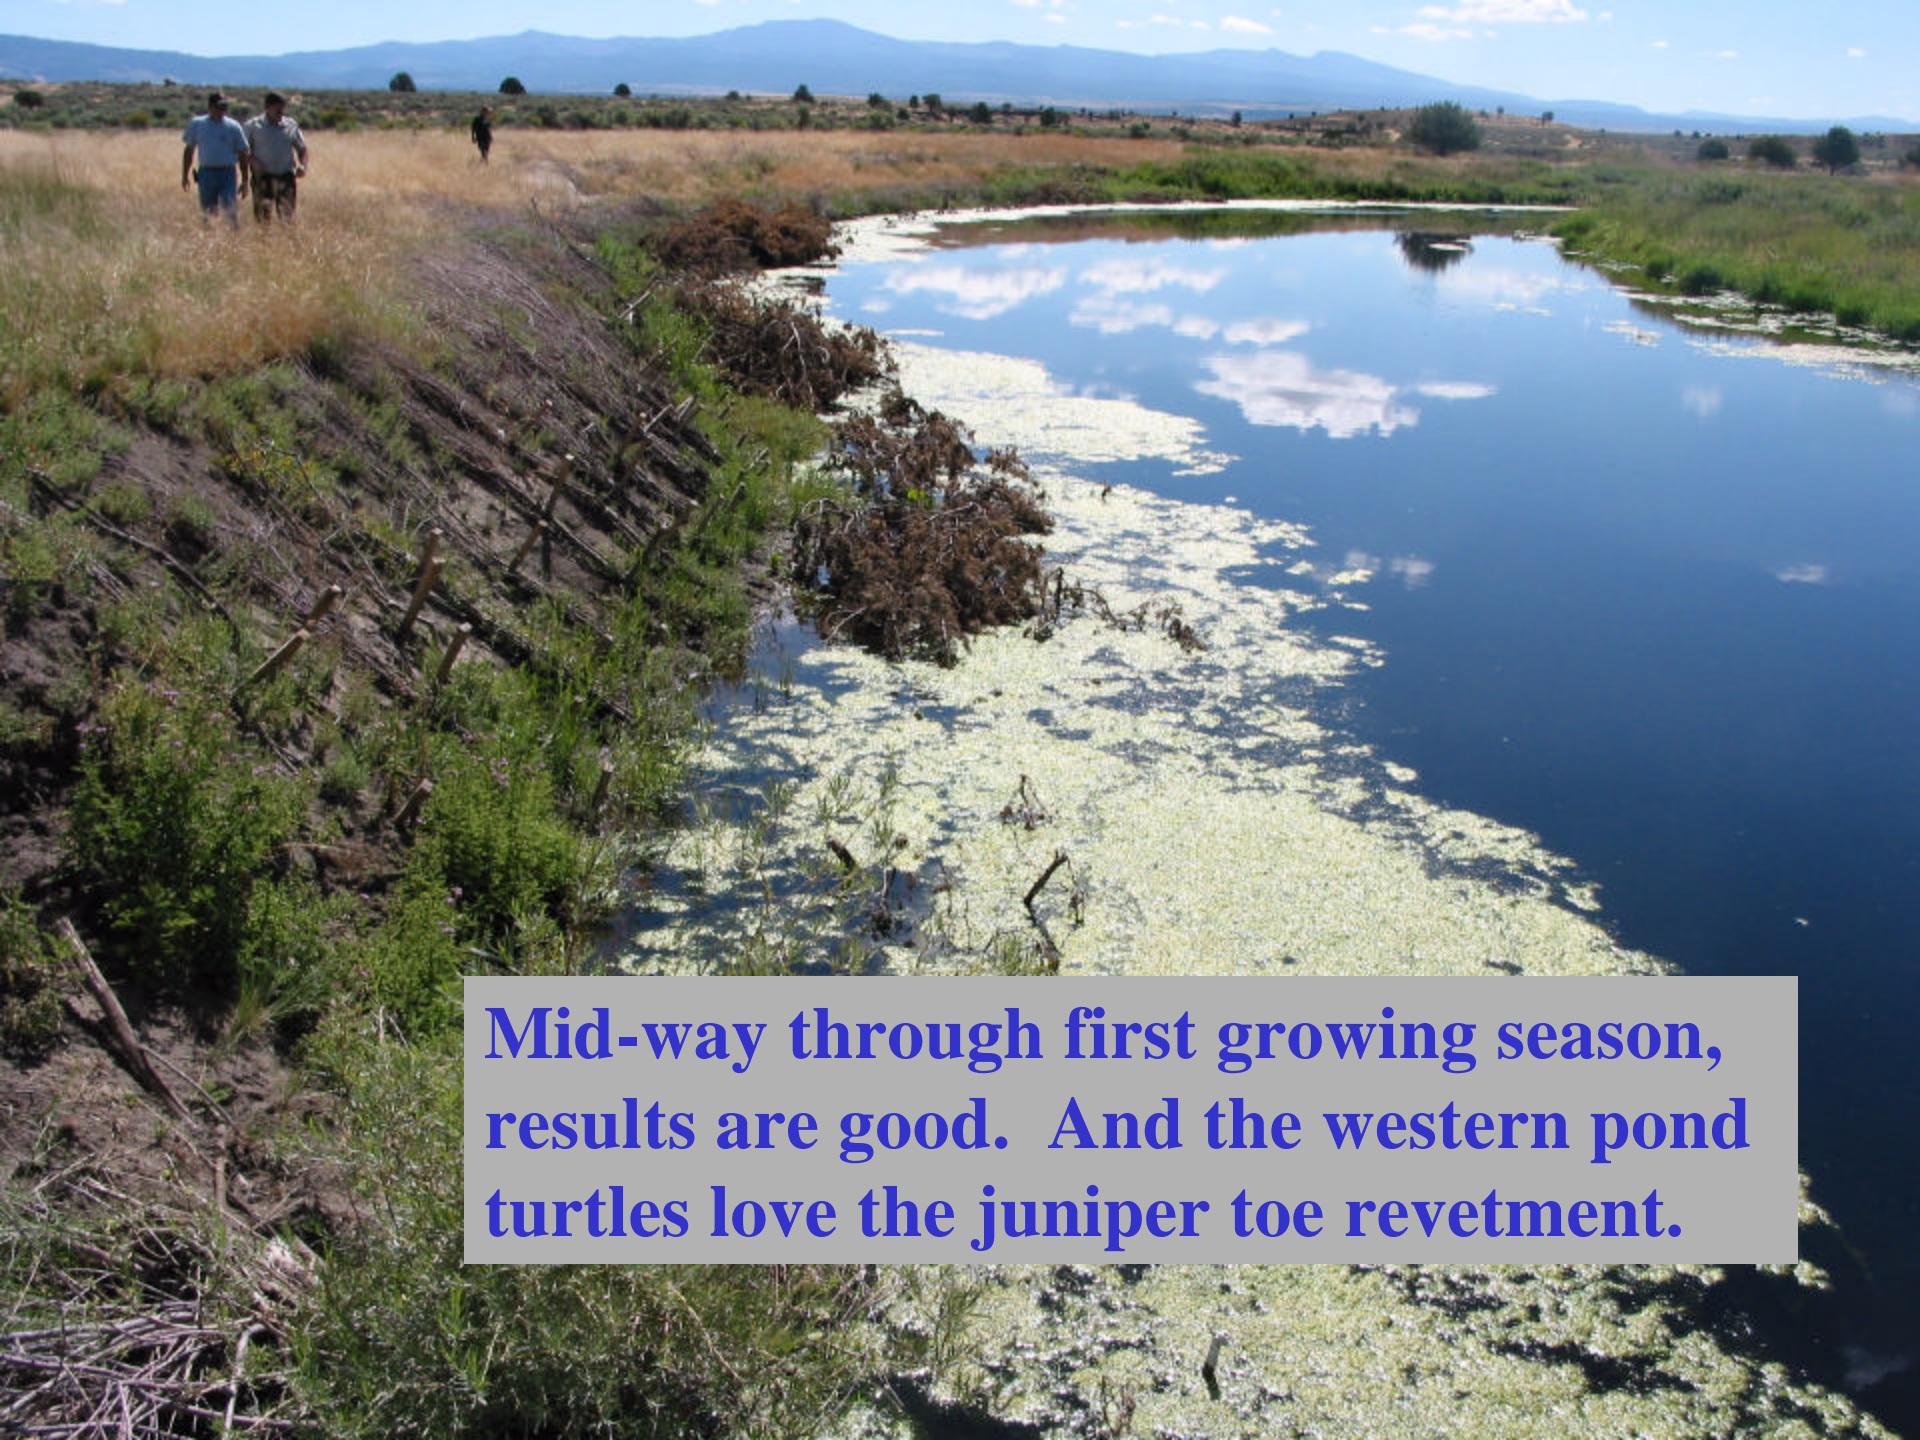
**Mid-way through first growing season,  
results are good. And the western pond  
turtles love the juniper toe revetment.**

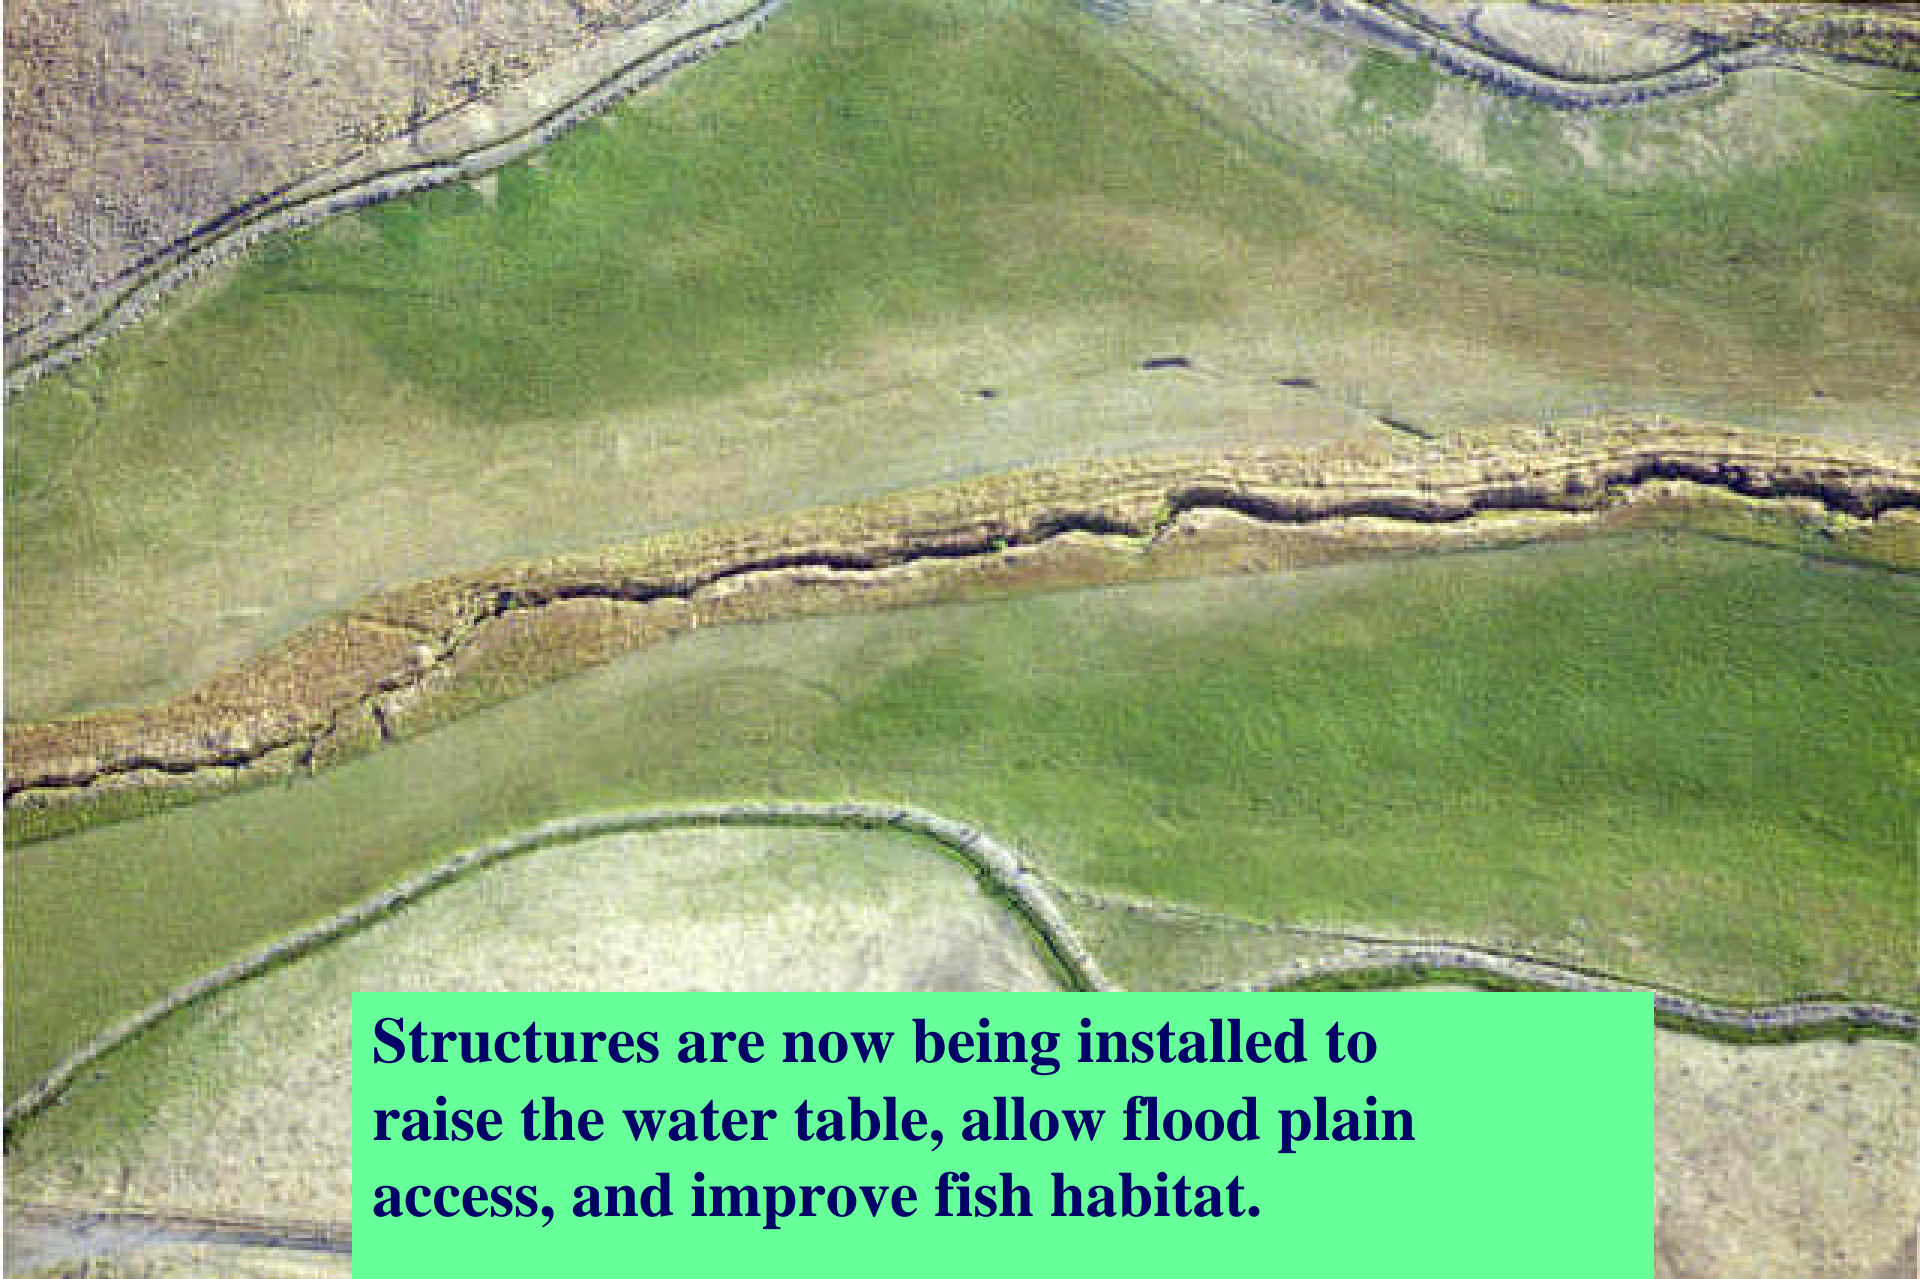
**Structures are now being installed to raise the water table, allow flood plain access, and improve fish habitat.**

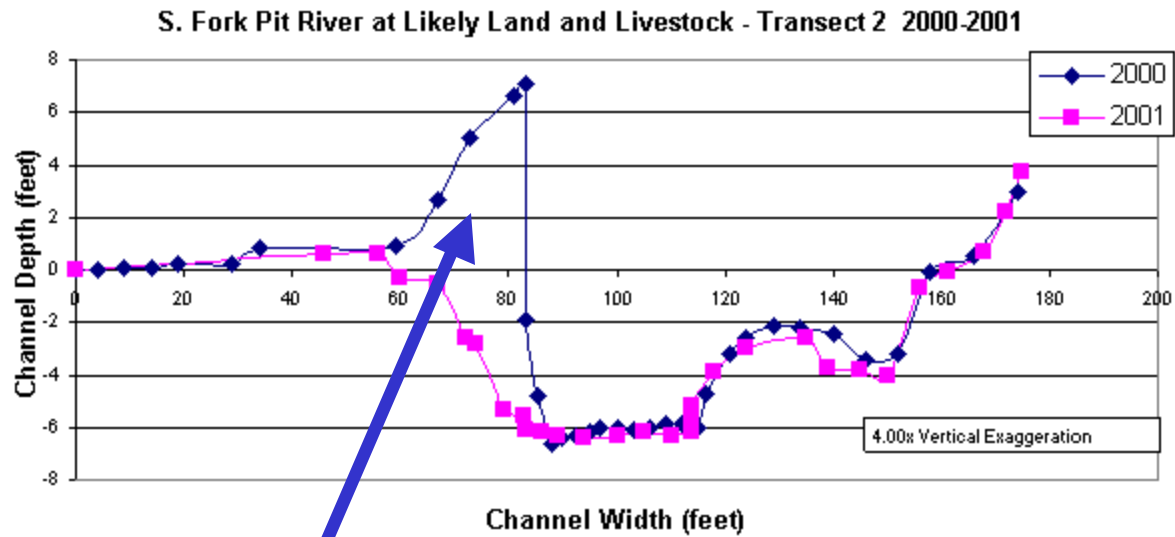
**Relict levee removed Spring 2001**

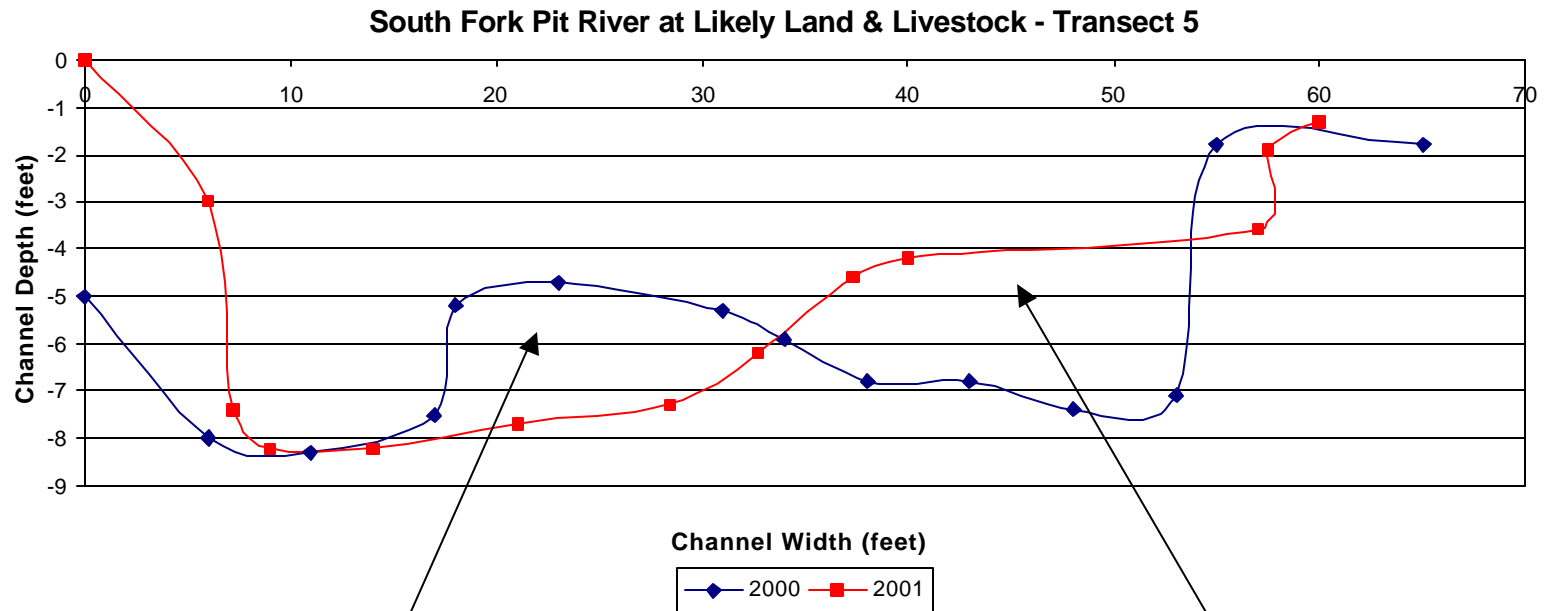
Mid channel depositional features were removed  
and new flood plain was created.

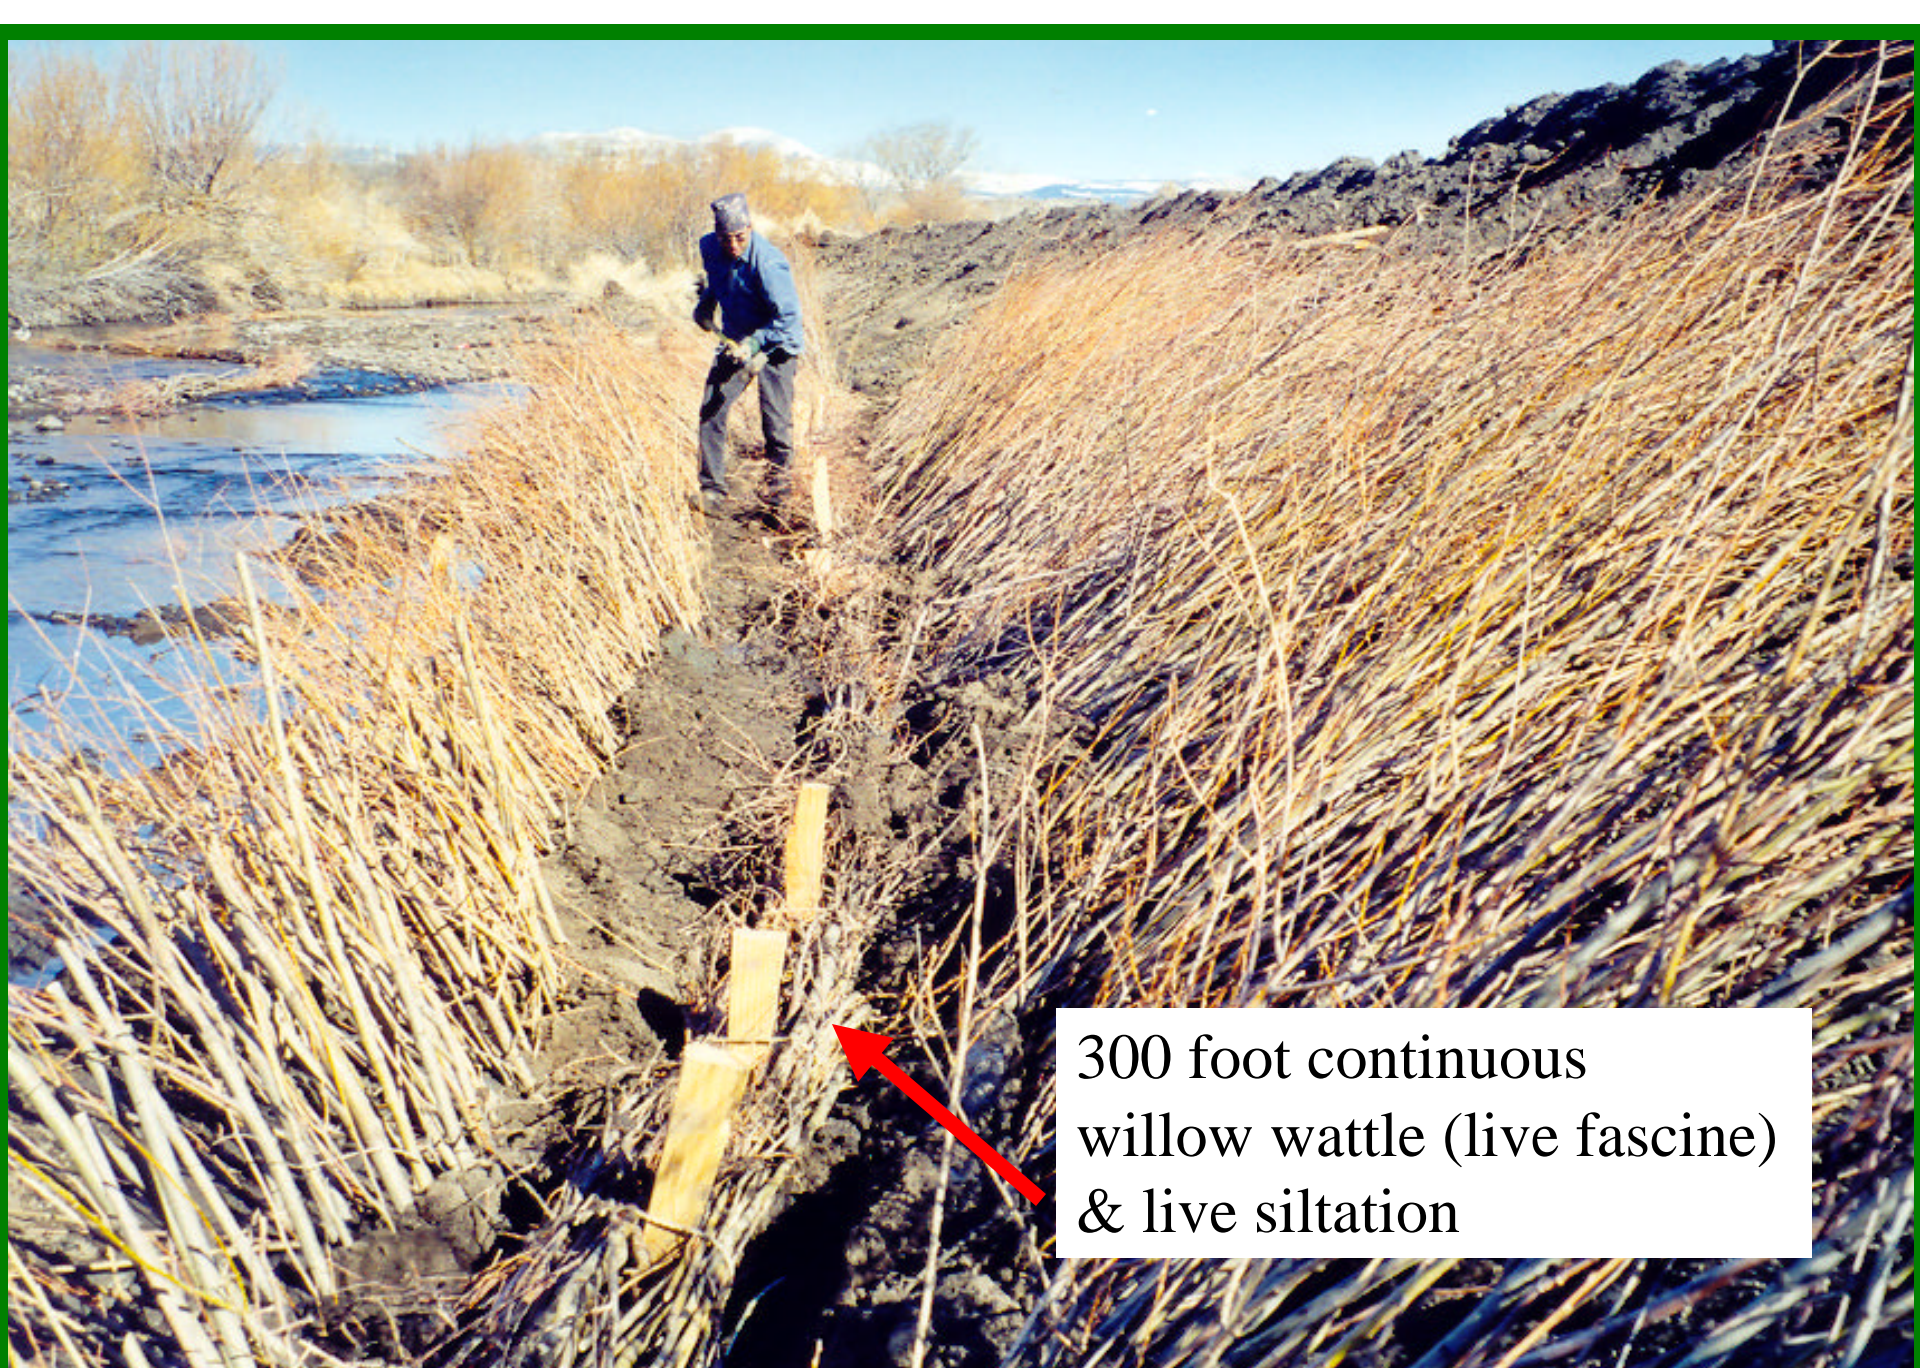
300 foot continuous  
willow wattle (live fascine)  
& live siltation

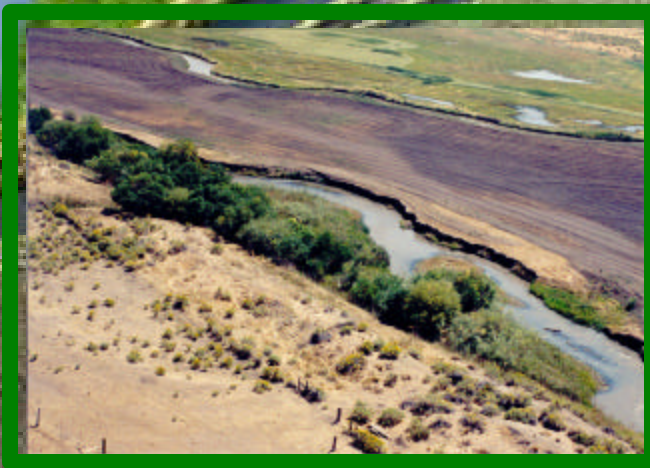
LTSTP installed to form wetlands and flood plain while protecting the adjacent meadow.

Also note new water gap for winter feeding area.

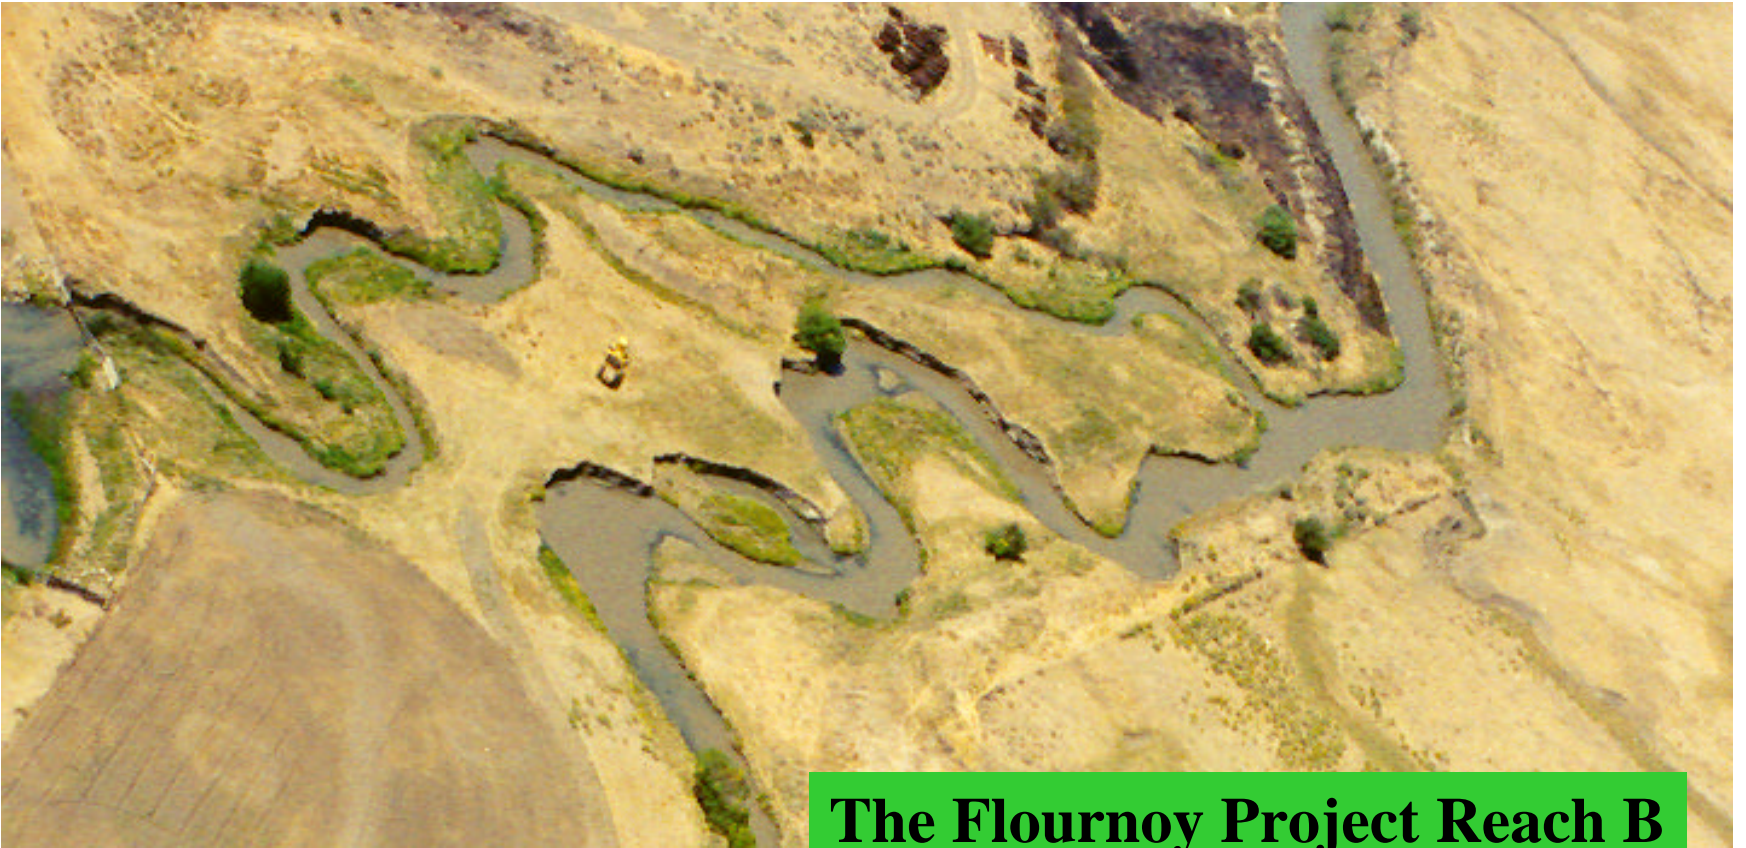
**The Flournoy Project Reach B  
created nearly 5 acres of flood  
plain and wetlands**

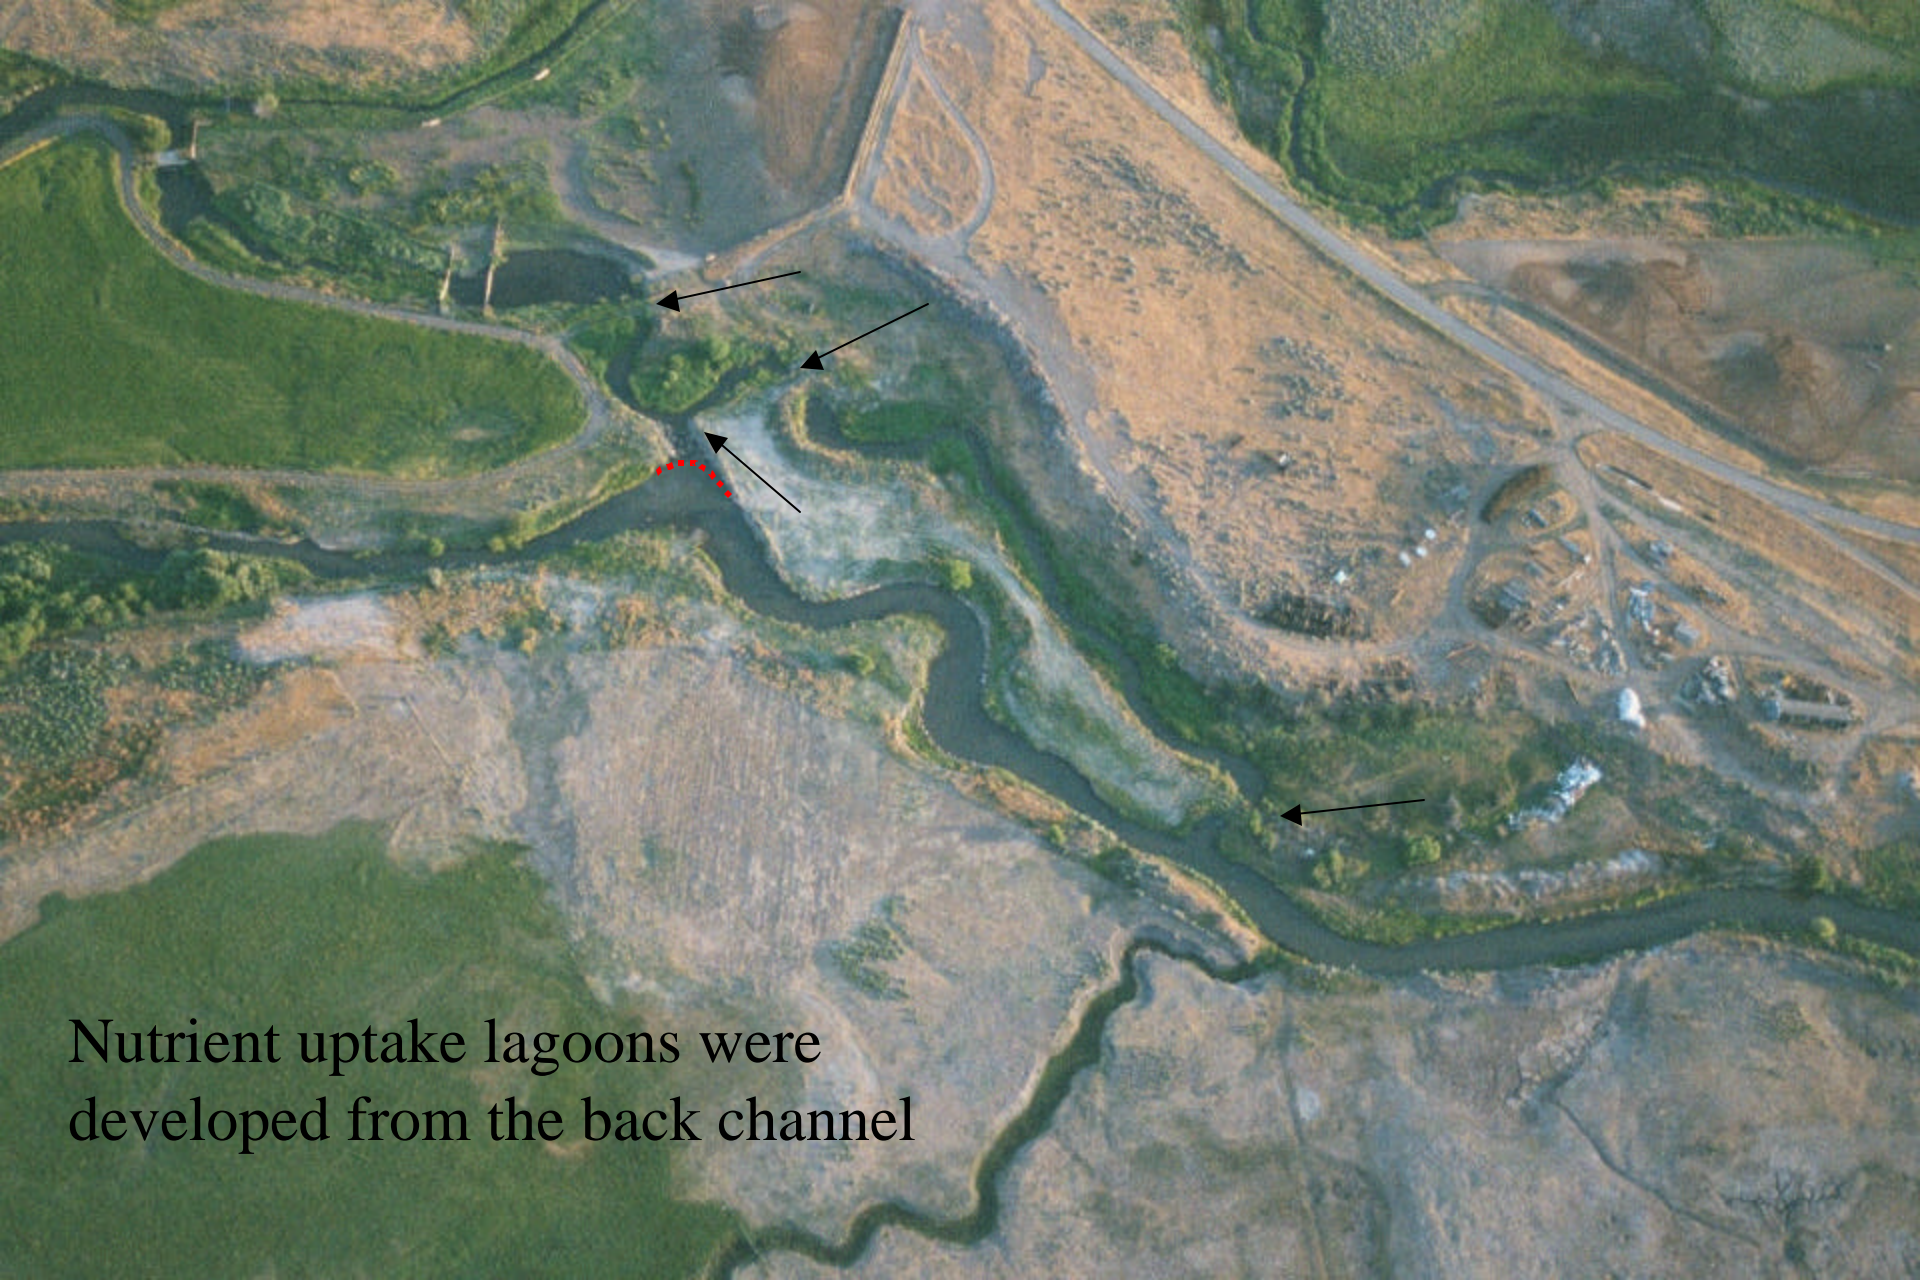
Nutrient uptake lagoons were developed from the back channel

**After treatment, high  
banks were gone, new  
flood plains were  
established, and  
feeding areas were  
isolated from the  
stream.**
